Reserve Analysis Report

Ridgemount Association

Las Vegas, Nevada

Version 2017-001 Final

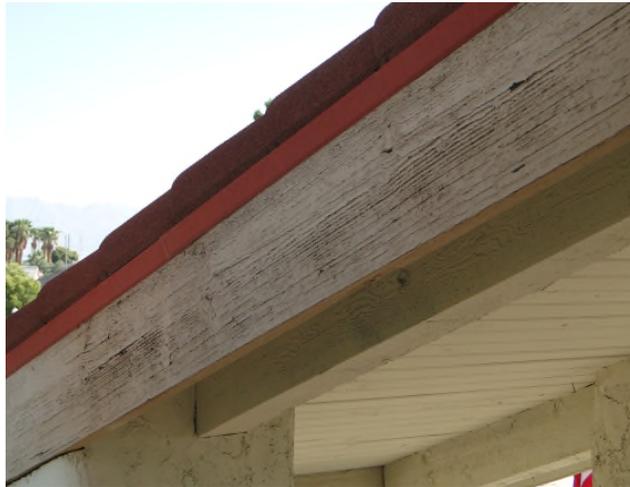
2017 - OBSERVATION ... The wood trim and fascia around the clubhouse is in poor condition needing sanding, sealer and paint.

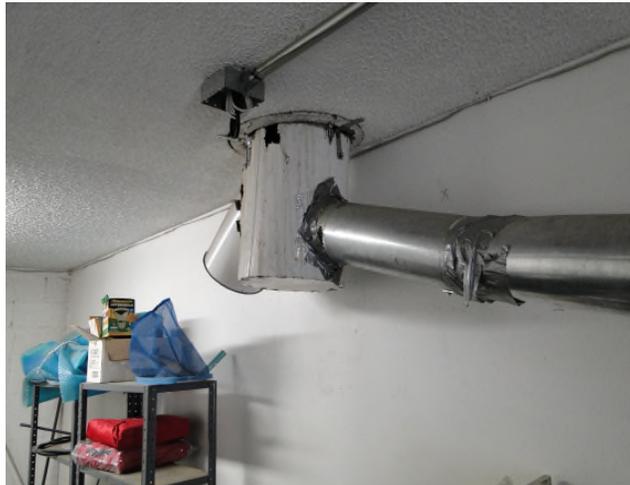
** Observation - Failing Heater Exhaust

2017 - During our 2017 site visit, we observed the heater exhaust duct was not very secure and the potential for leaks was concerning. It appears not to have been installed by a professional.

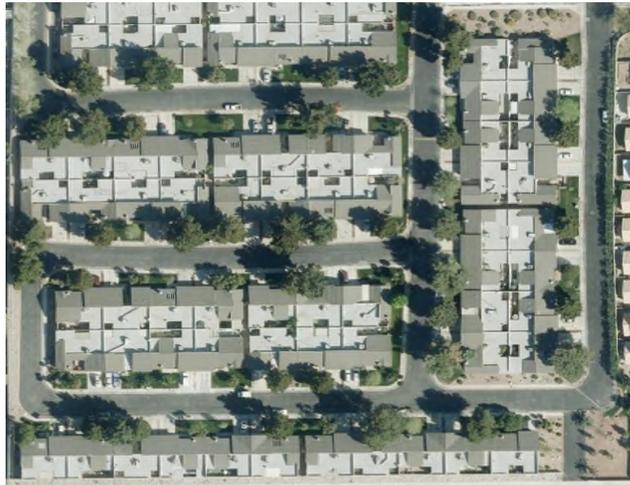
2017 - Approximately 30% of total asphalt was repaved in 2014, according to data supplied by the client. We have maintained the 5 phases of maintenance unless the client indicates otherwise. The exact timing for additional street rebuilding is not known as work like this is done when funds become available. Adjustments to other phase timing is made as needed. This component is for overlay/repair.

2012 - \$37,418 was spent on repaving approx 64,612sf of pavement of the main entry and a small portion of Goldmount.

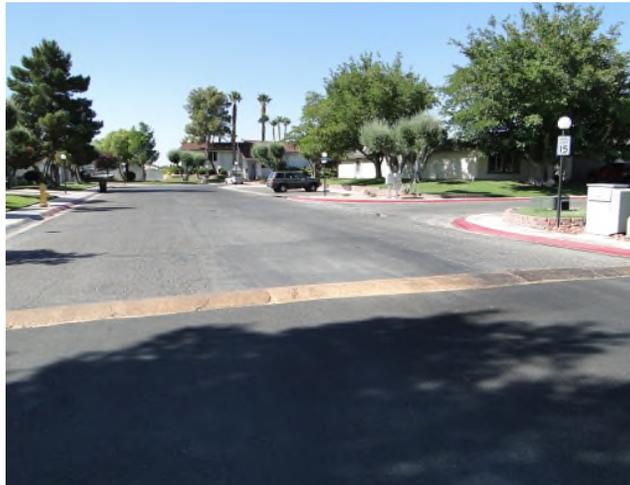
Category	010 Streets & Drives	Quantity	1 total
		Unit Cost	\$281,991.000
		% of Replacement	18.00%
		Current Cost	\$50,758.38
		Future Cost	\$53,328.02
Placed In Service	01/81		
Useful Life	30		
Adjustment	+8		
Remaining Life	2		
Replacement Year	2019

2017 - Approximately 30% of total asphalt was repaved in 2014, according to data supplied by the client. We have maintained the 5 phases of maintenance unless the client indicates otherwise. The exact timing for additional street rebuilding is not known as work like this is done when funds become available. Adjustments to other phase timing is made as needed. This component is for overlay/repair.

2012 - Overlay/renovation & maintenance components have been deferred 3 years due to funding levels and the need to build reserve funds. Further deferring of asphalt maintenance issues should be avoided as future maintenance costs increase on a non linear basis as time passes without adequate preventive maintenance measures.

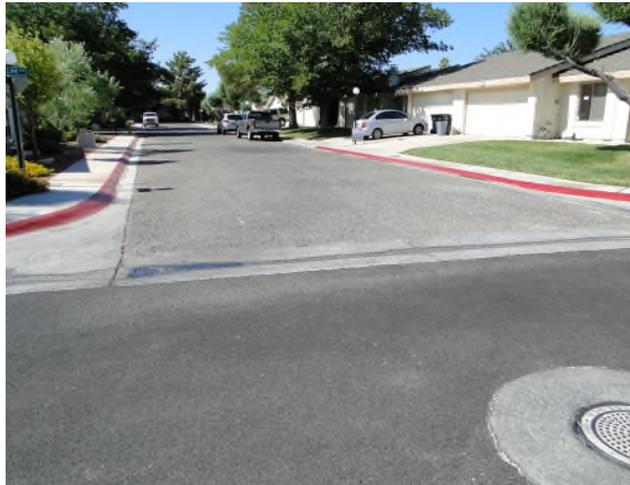
Category	010 Streets & Drives	Quantity	1 total
		Unit Cost	\$281,991.000
		% of Replacement	18.00%
		Current Cost	\$50,758.38
		Future Cost	\$54,661.22
Placed In Service	01/81		
Useful Life	30		
Adjustment	+9		
Remaining Life	3		
Replacement Year	2020

2017 - Approximately 30% of total asphalt was repaved in 2014, according to data supplied by the client. We have maintained the 5 phases of maintenance unless the client indicates otherwise. The exact timing for additional street rebuilding is not known as work like this is done when funds become available. Adjustments to other phase timing is made as needed. This component is for overlay/repair.

2012 - Overlay/renovation & maintenance components have been deferred 3 years due to funding levels and the need to build reserve funds. Further deferring of asphalt maintenance issues should be avoided as future maintenance costs increase on a non linear basis as time passes without adequate preventive maintenance measures.

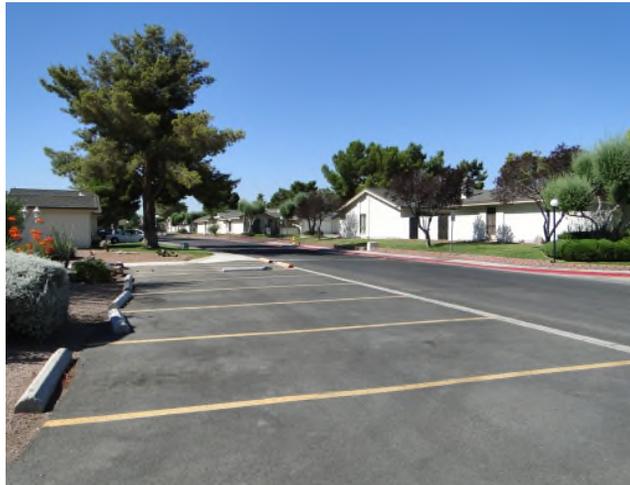
Category	010 Streets & Drives	Quantity	1 total
		Unit Cost	\$281,991.000
		% of Replacement	18.00%
		Current Cost	\$50,758.38
		Future Cost	\$56,027.75
Placed In Service	01/81		
Useful Life	30		
Adjustment	+10		
Remaining Life	4		
Replacement Year	2021

2017 - Approximately 30% of total asphalt was repaved in 2014, according to data supplied by the client. We have maintained the 5 phases of maintenance unless the client indicates otherwise. The exact timing for additional street rebuilding is not known as work like this is done when funds become available. Adjustments to other phase timing is made as needed. This component is for overlay/repair.

2012 - Overlay/renovation & maintenance components have been deferred 3 years due to funding levels and the need to build reserve funds. Further deferring of asphalt maintenance issues should be avoided as future maintenance costs increase on a non linear basis as time passes without adequate preventive maintenance measures.

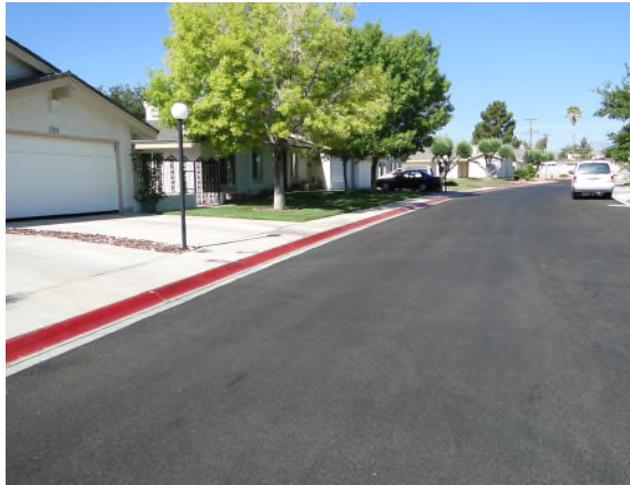
Category	010 Streets & Drives	Quantity	1 total
		Unit Cost	\$281,991.000
		% of Replacement	18.00%
		Current Cost	\$50,758.38
		Future Cost	\$57,428.45
Placed In Service	01/81		
Useful Life	30		
Adjustment	+11		
Remaining Life	5		
Replacement Year	2022

2017 - Approximately 30% of total asphalt was repaved in 2014, according to data supplied by the client. We have maintained the 5 phases of maintenance unless the client indicates otherwise. The exact timing for additional street rebuilding is not known as work like this is done when funds become available. Adjustments to other phase timing is made as needed. This component is for overlay/repair.

2012 - Overlay/renovation & maintenance components have been deferred 3 years due to funding levels and the need to build reserve funds. Further deferring of asphalt maintenance issues should be avoided as future maintenance costs increase on a non linear basis as time passes without adequate preventive maintenance measures.

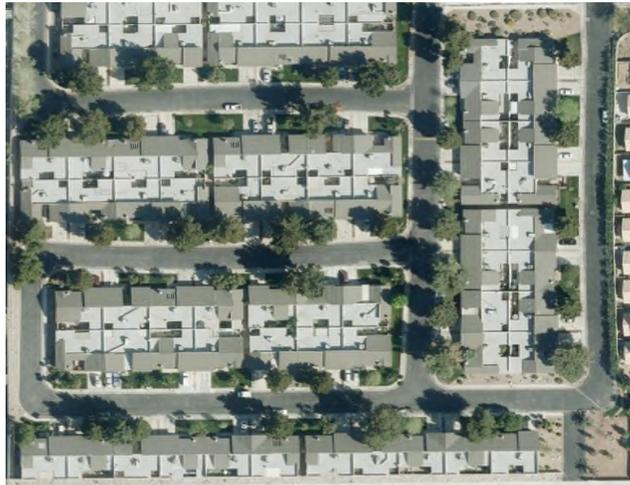
2017 - Timelines adjusted due to fund limitations. Deferring pavement maintenance will only increase future costs.

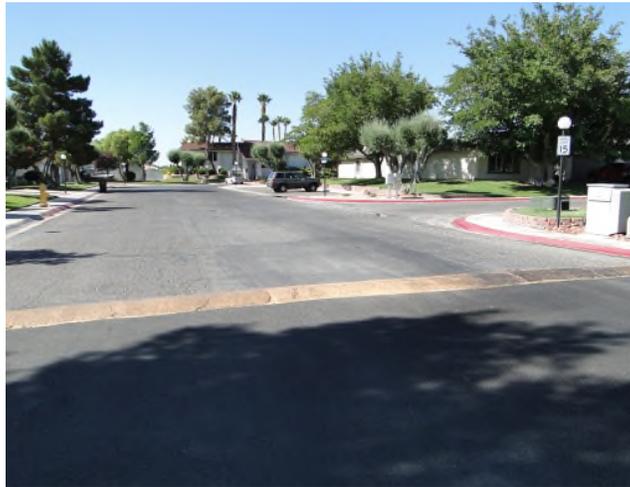
Category	010 Streets & Drives	Quantity	179,078 sq. ft.
		Unit Cost	\$5.500
		% of Replacement	1.00%
		Current Cost	\$9,849.29
Placed In Service	01/05	Future Cost	\$10,347.91
Useful Life	5		
Adjustment	+9		
Remaining Life	2		
Replacement Year	2019

2017 - Timelines adjusted due to fund limitations. Deferring pavement maintenance will only increase future costs.

2012 - Overlay/renovation & maintenance components have been deferred 3 years due to funding levels and the need to build reserve funds. Further deferring of asphalt maintenance issues should be avoided as future maintenance costs increase on a non linear basis as time passes without adequate preventive maintenance measures. The remaining life of the asphalt overlay has been adjusted to align with the future replacement cycles of the asphalt repairs and seal coating.

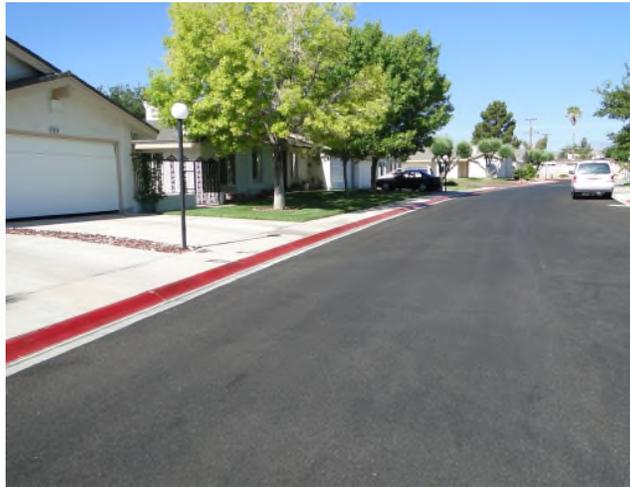
Category	010 Streets & Drives	Quantity	179,078 sq. ft.
		Unit Cost	\$0.200
		% of Replacement	20.00%
		Current Cost	\$7,163.12
		Future Cost	\$7,525.75
Placed In Service	01/13		
Useful Life	5		
Adjustment	+1		
Remaining Life	2		
Replacement Year	2019

2017 - Time frames and cost estimate adjusted.

2012 - Overlay/renovation & maintenance components have been deferred 3 years due to funding levels and the need to build reserve funds. Further deferring of asphalt maintenance issues should be avoided as future maintenance costs increase on a non linear basis as time passes without adequate preventive maintenance measures. The remaining life of the asphalt overlay has been adjusted to align with the future replacement cycles of the asphalt repairs and seal coating.

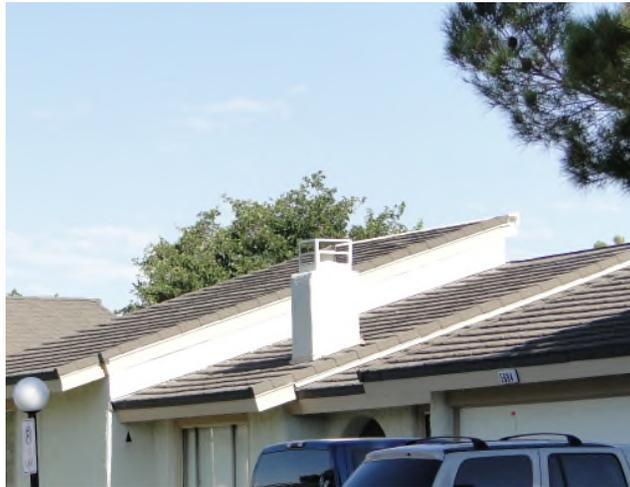
Category	020 Roofs	Quantity	140 units
		Unit Cost	\$150.000
		% of Replacement	100.00%
		Current Cost	\$21,000.00
Placed In Service	01/06	Future Cost	\$23,180.07
Useful Life	15		
Remaining Life	4		
Replacement Year	2021

2012 - By the end of 2006 all shake roofs have been replaced with Decra-Shake stone-coated steel panels (186,478sf) at a cost of \$523,000. This component was funded with a special assessment.

The Decra-Shake panels themselves are designed to last the life of the community (50+ years warranty). However, the roofing materials below the shingles do not have an indefinite life. Many factors affect the longevity of roofs, including tile. Installation quality, type of roofing material, human contact with the roofs, and environment. In hot climates, roofing paper can fail prematurely. We have budgeted for a percentage of repairs to the roof(s) every 10-15 years. The actual condition of these roofs should be monitored through time and adjustments made as necessary. However, all roofs should receive an annual inspection, by a licensed professional (funded by operating \$) and roofs should receive maintenance every 3-5 years, as needed, depending on the location and weather conditions.

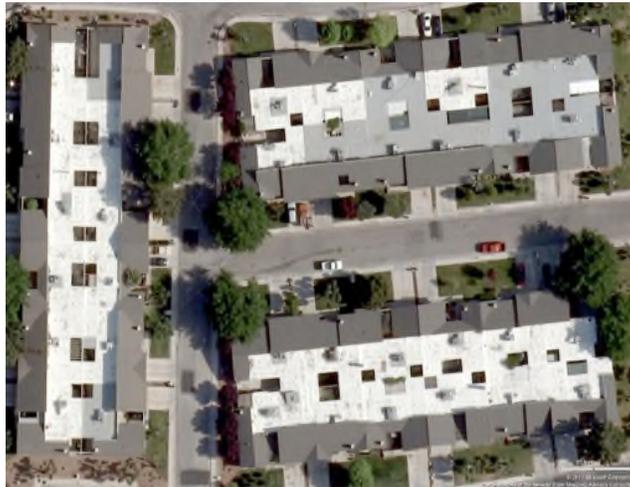
2017 - There are 19 buildings. Building 3 is all tile, building 4 contains a very small section of flat and the remaining 17 all contain a measured amount of flat builtup roofing. We have used a 20 year life which may vary by roof. Likely the association will make repairs until no longer financially feasible.

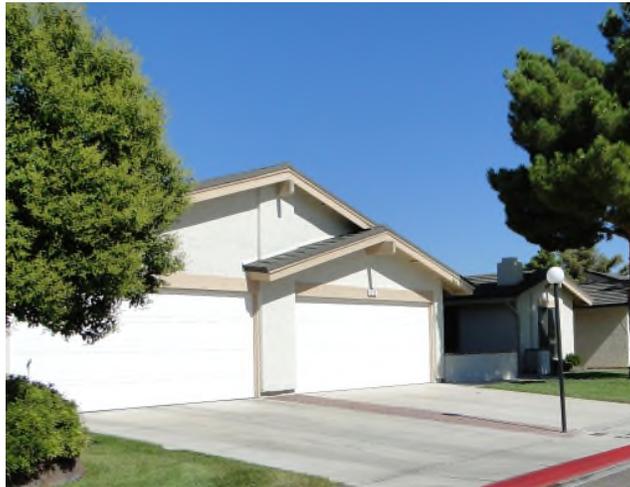
Category	030 Painting	Quantity	1 total
		Unit Cost	\$18,000.000
		% of Replacement	100.00%
		Current Cost	\$18,000.00
Placed In Service	01/16	Future Cost	\$22,479.53
Useful Life	10		
Remaining Life	9		
Replacement Year	2026

2017 - Per unit cost adjusted per Empire Painting 2016 cost to prep and paint building 5. Remaining life extended to two years due to fund level in 2017.

2012 - All buildings have had major stucco repair/renovation and painting between 2002 and 2011. This page and the remaining "building painting" pages highlight that maintenance timeline. The budgeted cost is an average for routine stucco repair and painting.

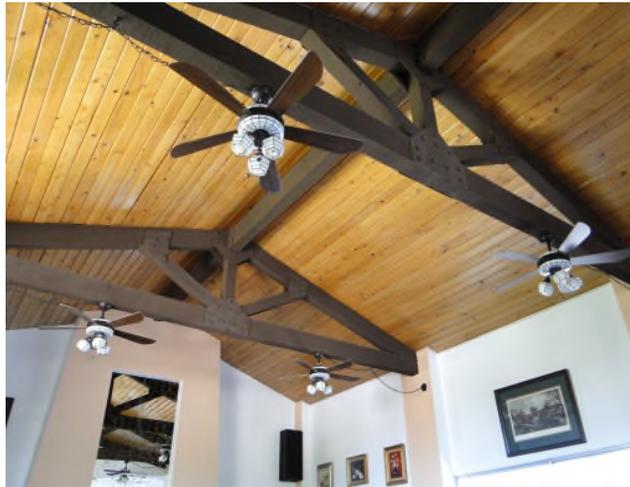
Category	030 Painting	Quantity	792 sq. ft.
		Unit Cost	\$2.000
		% of Replacement	100.00%
		Current Cost	\$1,584.00
Placed In Service	01/07	Future Cost	\$2,027.65
Useful Life	20		
Remaining Life	10		
Replacement Year	2027

2017 - Sq ft cost estimate adjusted.

2012 - Client indicates that this was done in 2007. Cost not known. Assume in-house.

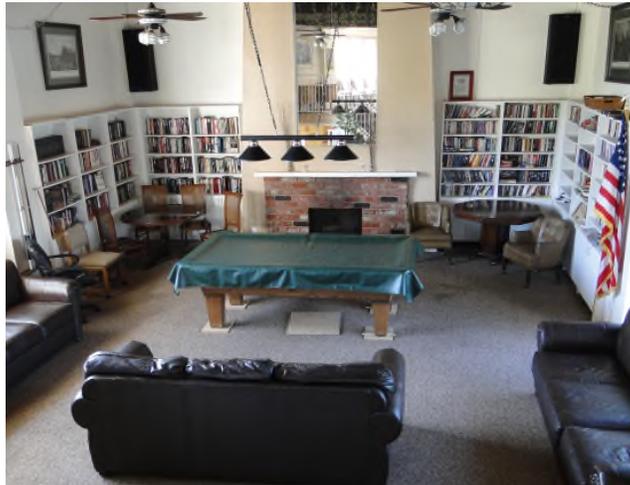
Category	030 Painting	Quantity	5,156 sq. ft.
		Unit Cost	\$0.770
		% of Replacement	100.00%
		Current Cost	\$3,970.12
Placed In Service	01/12	Future Cost	\$4,491.83
Useful Life	10		
Remaining Life	5		
Replacement Year	2022

2012 - No change to this component.

2012 - This is for painting of the interior walls of the clubhouse. Cost provided by client and shown to be done in 2012. The remaining life was adjusted accordingly.

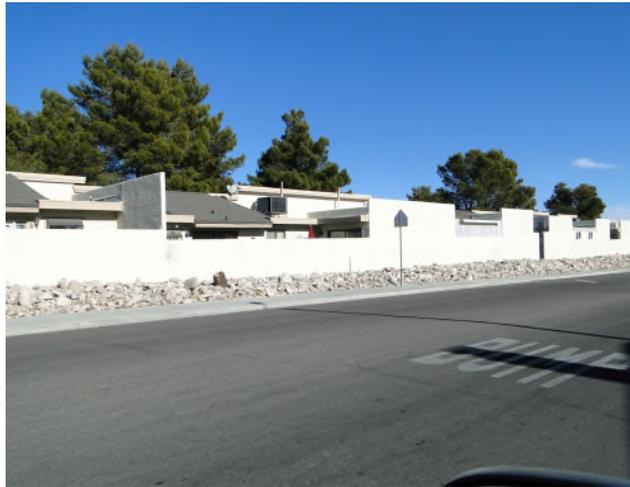
Category	030 Painting	Quantity	18,680 sq. ft.
		Unit Cost	\$0.600
		% of Replacement	100.00%
		Current Cost	\$11,208.00
		Future Cost	\$11,775.41
Placed In Service	01/08		
Useful Life	10		
Adjustment	+1		
Remaining Life	2		
Replacement Year	2019

2017 - Adjusted useful and remaining lives.

2012 - This is for painting of the perimeter stucco and block walls. SF approximately 18,680sf. 2008 actual cost used and inflated to 2012.

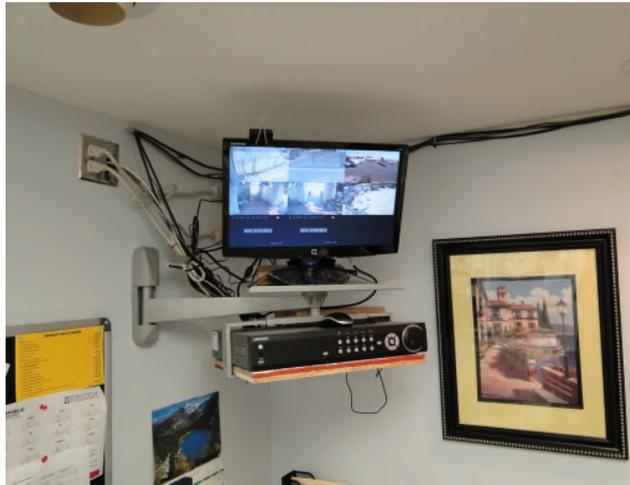
2017 - DVR moved to air handler room (outside). We don't know if this is a good idea with wind and dust contamination a possibility.

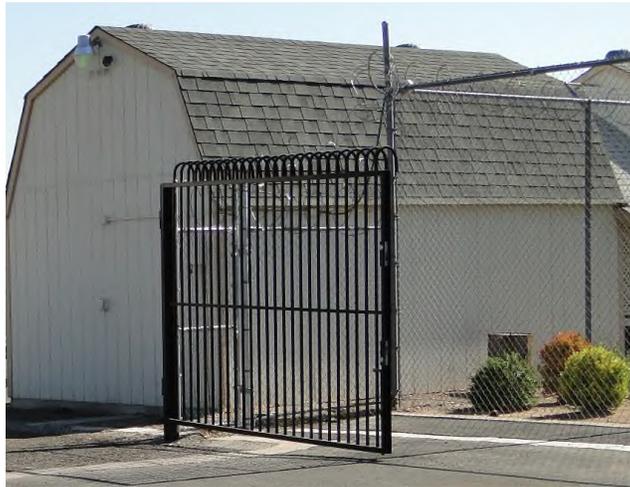
Category	040 Fencing	Quantity	1 total
		Unit Cost	\$15,895.000
		% of Replacement	100.00%
		Current Cost	\$15,895.00
		Future Cost	\$26,045.81
Placed In Service	01/17		
Useful Life	20		
Remaining Life	20		
Replacement Year	2037

2017 - This fencing component has been added this year as a result of changes in Nevada law which now requires that all components that the association may, at some point, be required to expend funds on be added to the reserve study, whether funded or not at this time.

This component includes chain link fencing surrounding the RV storage lot and the tennis court and park area adjacent to the RV lot.

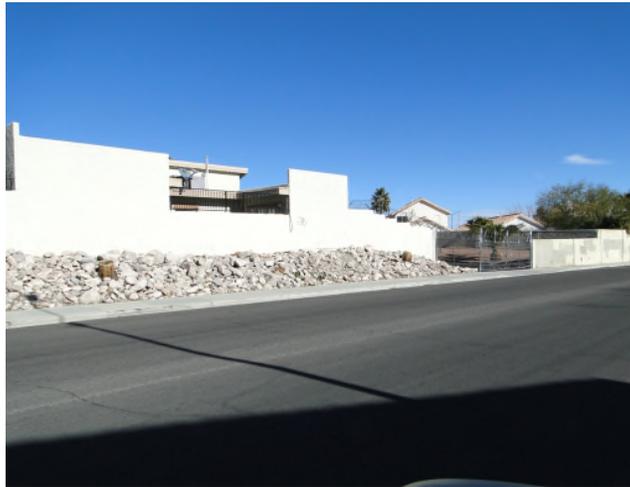
2017 - Along with this item for major repairs, a line item should be added to the operating budget for ongoing minor maintenance and touch-up of the wall, especially where grafitti is concerned.

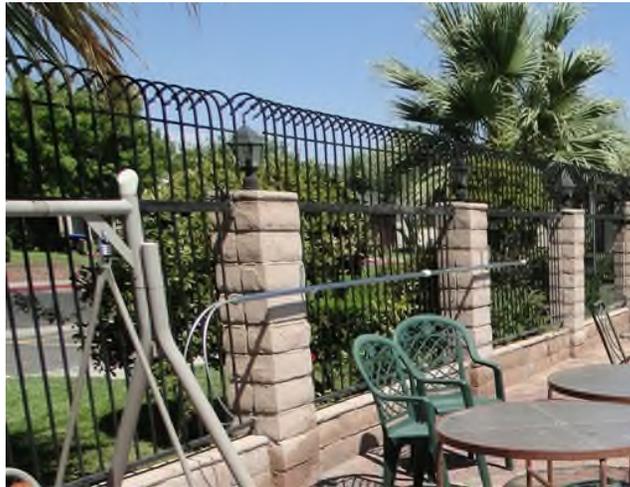
2017 - Our 2017 site visit observed rusting in various areas. This fencing should be rust treated and painted to prevent further deterioration of the metal and joints.

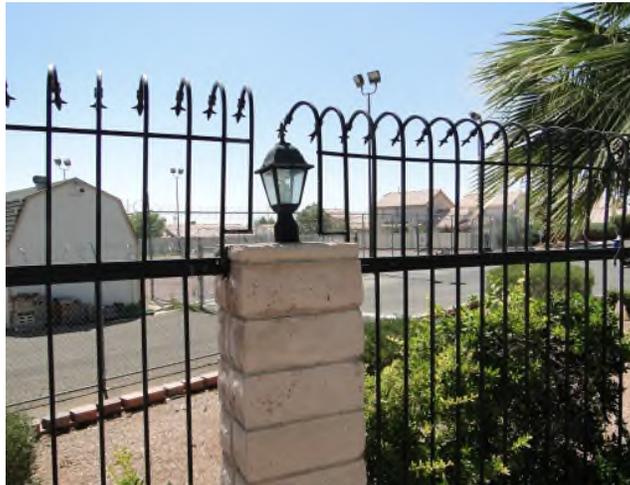
Category	050 Lighting	Quantity	22 lanterns
		Unit Cost	\$81.950
		% of Replacement	100.00%
		Current Cost	\$1,802.90
Placed In Service	01/09	Future Cost	\$2,424.70
Useful Life	20		
Remaining Life	12		
Replacement Year	2029

2012 - According to the client, the fence post lanterns were replaced in 2009.

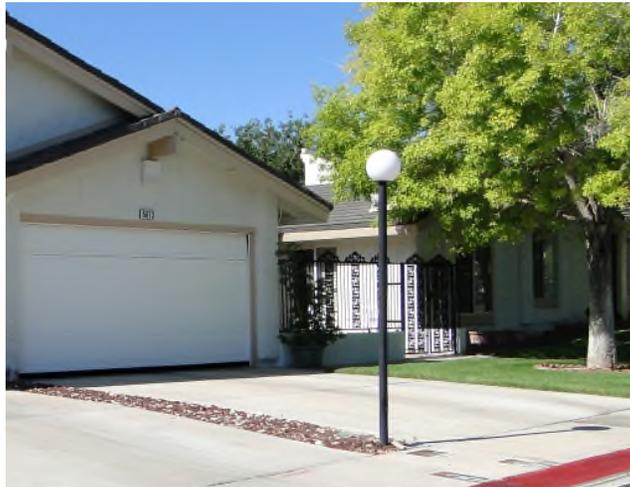
2017 - Those poles that are located in turf or dirt areas prone to moisture show corrosion around the base. These should be inspected and replaced if badly corroded.

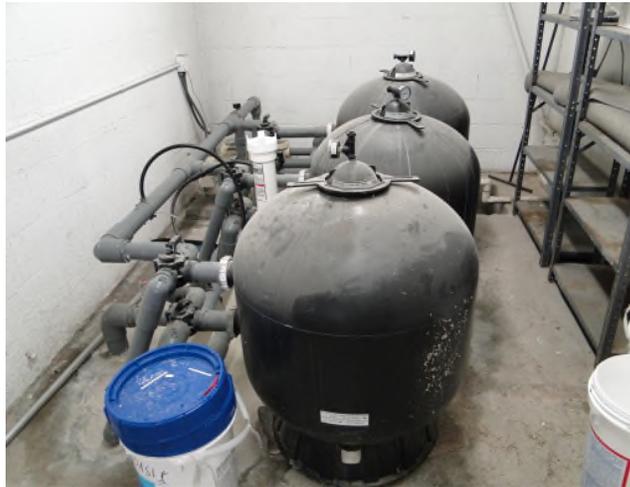
2017 - These are supposedly the same units per staff personnel. If so, they are past their life expectancy. No data available on operating condition.

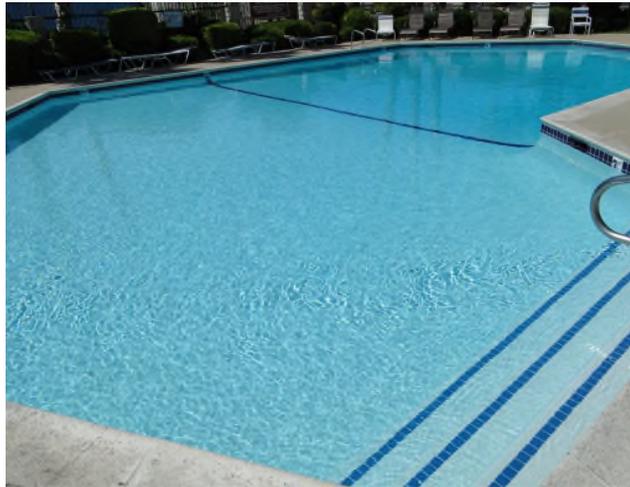
Category	060 Pools & Spas	Quantity	1 total
		Unit Cost	\$18,488.000
		% of Replacement	100.00%
		Current Cost	\$18,488.00
Placed In Service	01/07	Future Cost	\$20,407.29
Useful Life	14		
Remaining Life	4		
Replacement Year	2021

2012 - 2007 cost revised by client to \$18,488. Work was done by Alamo Pool.

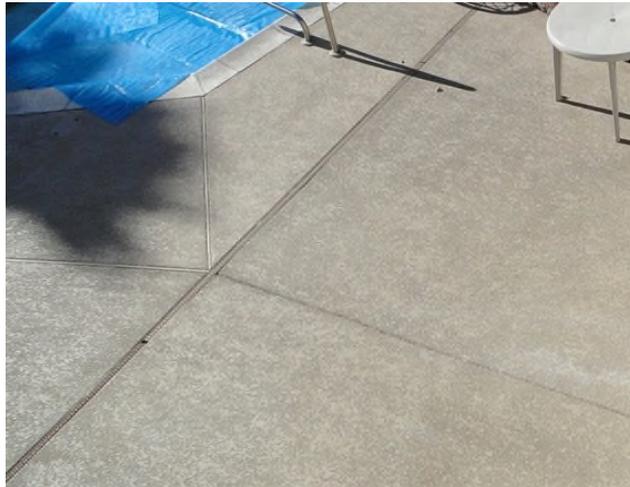
Category	060 Pools & Spas	Quantity	1 total
		Unit Cost	\$4,681.000
		% of Replacement	100.00%
		Current Cost	\$4,681.00
		Future Cost	\$5,296.12
Placed In Service	08/10		
Useful Life	12		
Remaining Life	5		
Replacement Year	2022

2012 - In August of 2010 the deck was "resurfaced". We do not know if this means totally resurfacing of the deck or repair and repainting of the deck. We estimated 2352sf of deck surface. The actual cost to remove and apply a new "Kooldeck" will be considerably higher and an actual estimate should be factored in to the next annual update.

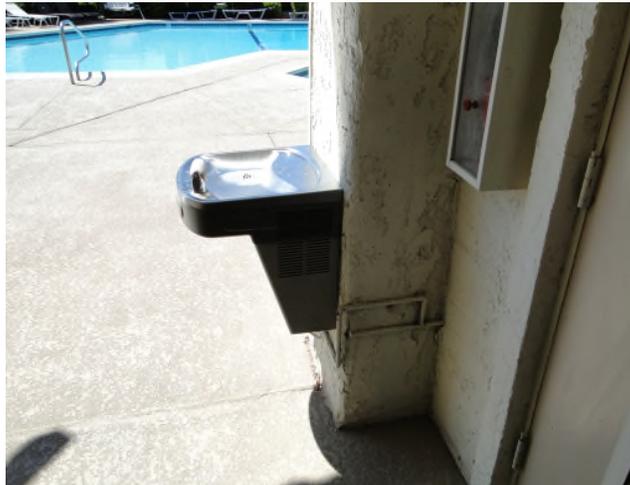
Category	060 Pools & Spas	Quantity	1 fountain
		Unit Cost	\$560.000
		% of Replacement	110.00%
		Current Cost	\$616.00
		Future Cost	\$679.95
Placed In Service	01/09		
Useful Life	12		
Remaining Life	4		
Replacement Year	2021

2017 - Adjusted est. cost and added 10% removal, replacement and disposal.

2012 - According to the client, this fountain was replaced in 2009.

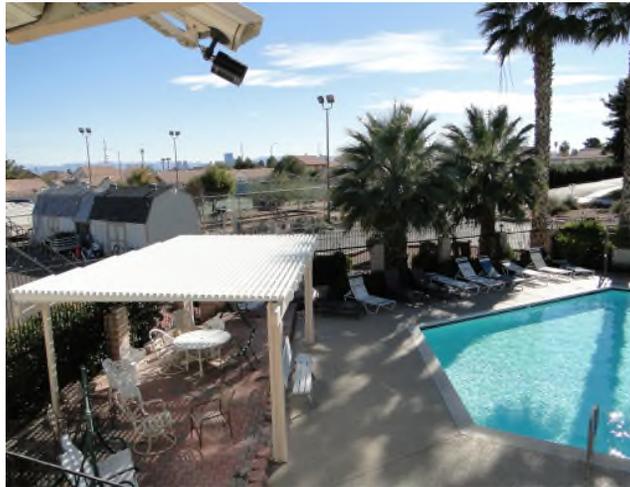
Category	060 Pools & Spas	Quantity	1 total
		Unit Cost	\$5,174.000
		% of Replacement	50.00%
		Current Cost	\$2,587.00
		Future Cost	\$2,651.68
Placed In Service	01/12		
Useful Life	6		
Remaining Life	1		
Replacement Year	2018

2012 - These furnishings are replaced on an as-needed basis.

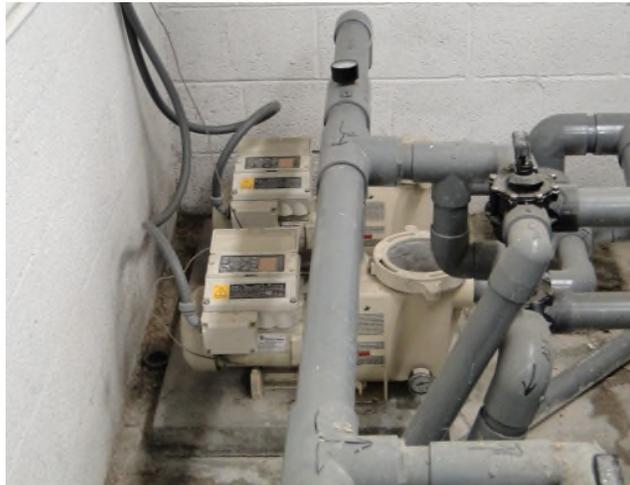
Category	060 Pools & Spas	Quantity	4 pump/motors
		Unit Cost	\$1,800.000
		% of Replacement	100.00%
		Current Cost	\$7,200.00
Placed In Service	01/11	Future Cost	\$7,947.45
Useful Life	10		
Remaining Life	4		
Replacement Year	2021

2012 - These are the new style pool and spa motors and pumps. Based on information from the pool company, they are Intelli-Flo smart pumps, 174 max gpm and are new.

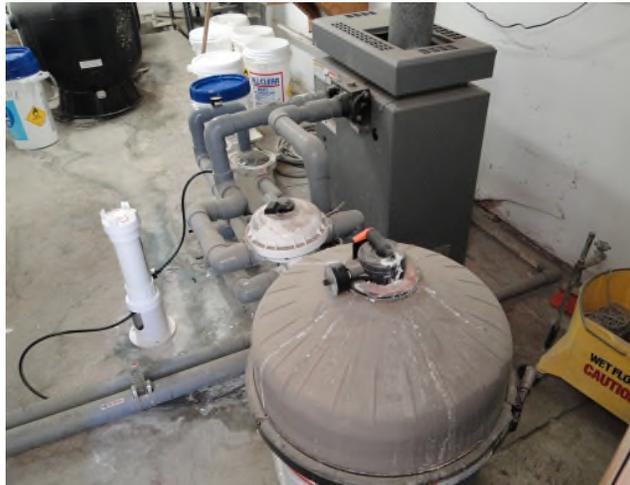
Category	060 Pools & Spas	Quantity	1 filter
		Unit Cost	\$716.000
		% of Replacement	100.00%
		Current Cost	\$716.00
		Future Cost	\$752.25
Placed In Service	01/09		
Useful Life	10		
Remaining Life	2		
Replacement Year	2019

2012 - This filter was replaced in 2009.

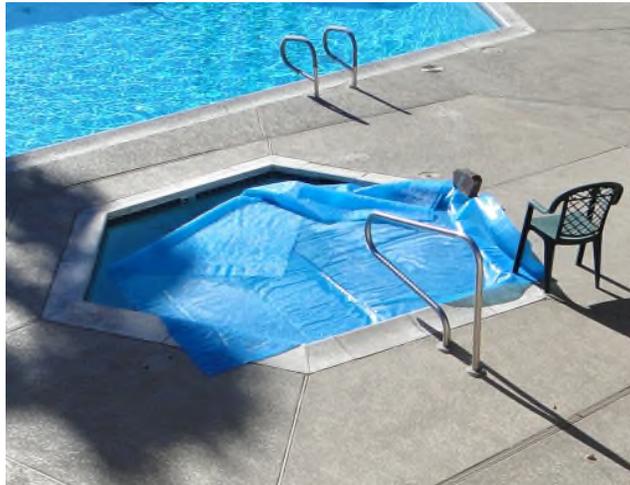
Category	060 Pools & Spas	Quantity	1 total
		Unit Cost	\$2,200.000
		% of Replacement	100.00%
		Current Cost	\$2,200.00
		Future Cost	\$2,816.19
Placed In Service	01/11		
Useful Life	10		
Adjustment	-4		
Remaining Life	0		
Replacement Year	2017

2017 - Per management, the spa will be replastered and tiles in 09/2017 at a cost of \$2200.

2012 - The spa was replastered in 2011 at a cost of \$1750.

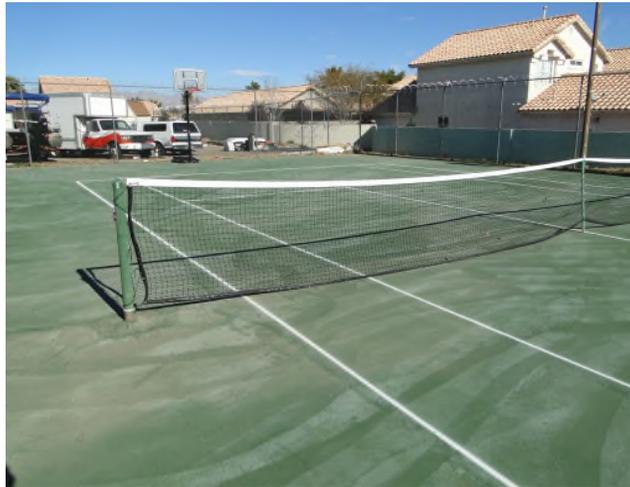
2017 - The remaining tennis court needs a cleaning and a top coat to preserve the asphalt or it will rapidly deteriorate and cost considerably more to renovate.

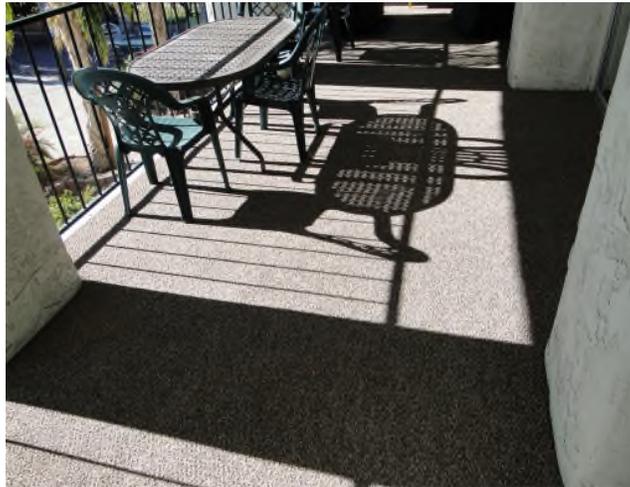
2017 - A tear was observed in this carpet during our 2017 site visit, however, the remainder of the carpet appeared in good condition. The tear can be repaired.

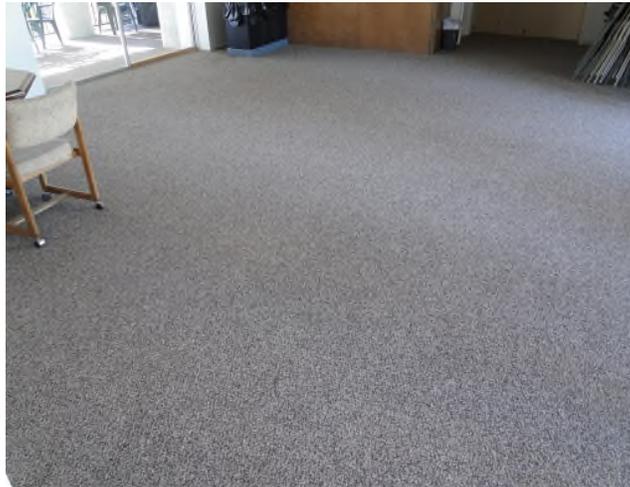
2017 - Carpet appears in good condition and not in need of replacement.

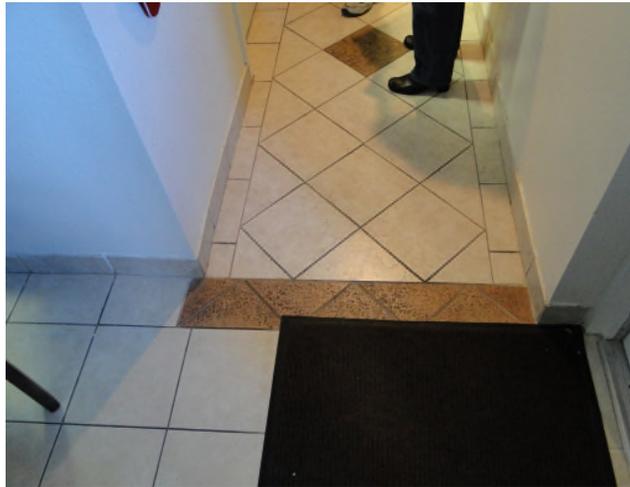
2012 - This is the entry and hallway tile flooring. This tile should last 30+ years depending on amount and type of traffic. Lower floor hallways and restrooms are now included.

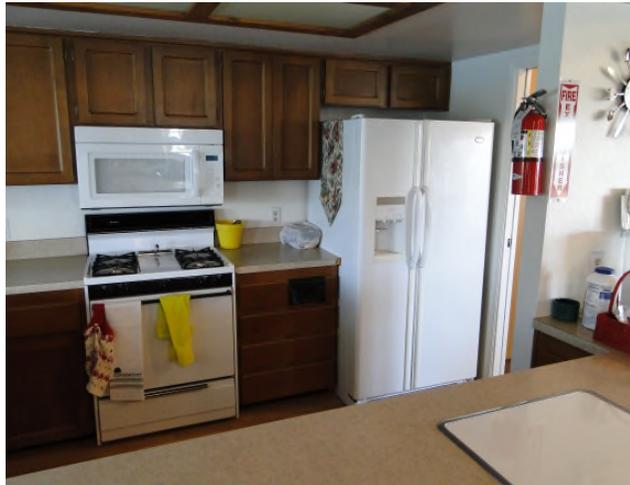
Category	070 Interior	Quantity	1 total
		Unit Cost	\$2,300.000
		% of Replacement	100.00%
		Current Cost	\$2,300.00
		Future Cost	\$2,538.77
Placed In Service	01/01		
Useful Life	15		
Adjustment	+5		
Remaining Life	4		
Replacement Year	2021

2017 - The refrigerator and micro were replaced around 2015 (no date supplied).

2012 - These are the appliances located at the clubhouse kitchen. In 2009 a microwave was installed above the stove. Additionally, a refrigerator and dishwasher were donated.

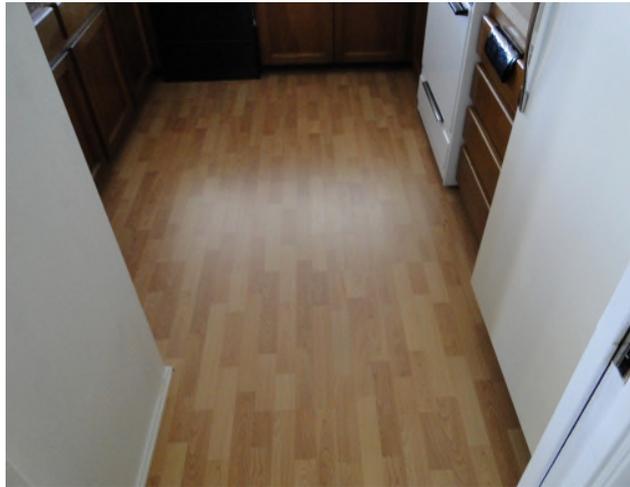
Category	070 Interior	Quantity	60 sq. ft.
		Unit Cost	\$16.000
		% of Replacement	105.00%
		Current Cost	\$1,008.00
Placed In Service	01/15	Future Cost	\$2,012.47
Useful Life	30		
Remaining Life	28		
Replacement Year	2045

2012 - This Pergo wood flooring was installed in 2011 in the kitchen area. The estimated replacement cost factors material and install with like material.

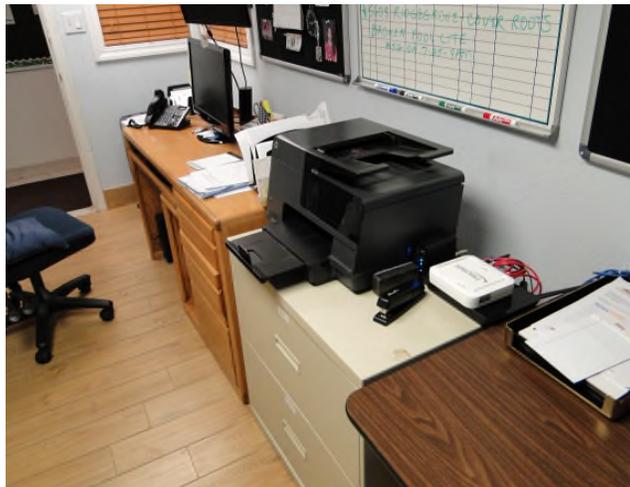
2017 - The multi-function printer was replaced. Estimated funding adjusted.

2012 - In 2010-2011 the following equipment changes were made:

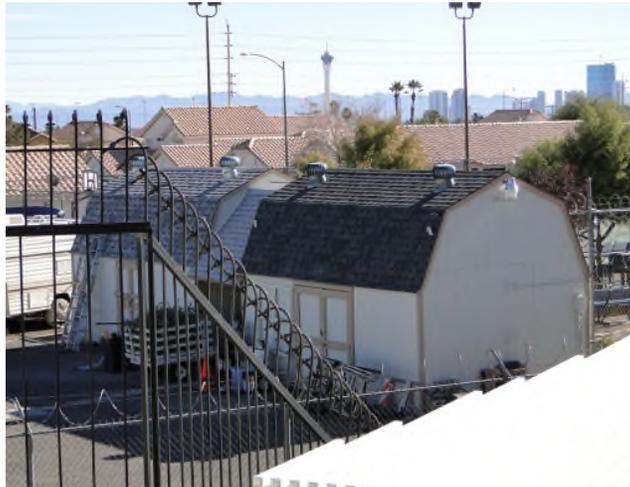
2017 - According to management, the sheds were painted and repaired in 2016.

2012 - These are the two storage sheds located in the RV storage and Maintenance yard. A third shed is owned by one of the owners. The estimated cost to replace is provided by the client. They were painted in 2011.

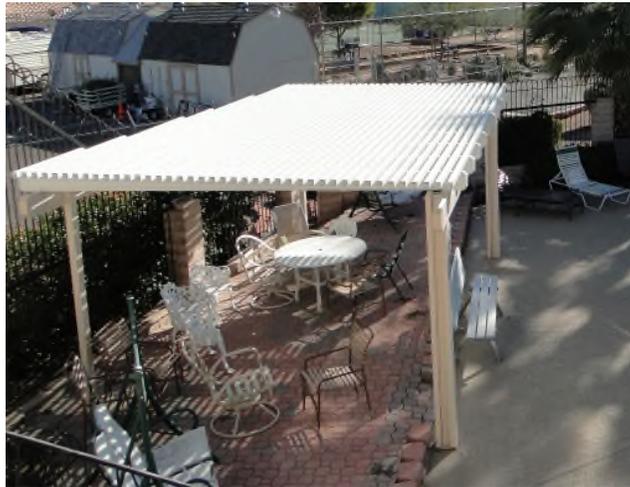
2017 - No change to this component.

2012 - A shade structure was installed in the pool patio area in 2012. It is approximately 8' x 16' and appears to be constructed of corrugated vinyl plastic or aluminum. We are estimating the cost pending confirmation of actual.

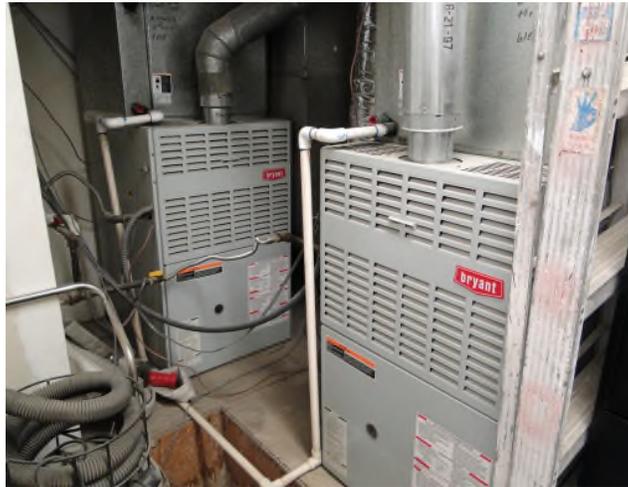
2017 - No change to this component.

2012 - These are the HVAC units and air handlers located at the clubhouse. In 2007, a 5 ton Aman Goodman condenser unit (\$2400) was installed replacing one of the older units. Repairs were also made on the AC units replacing components at \$2800.

The remaining life of the HVAC compressor units has been adjusted to align with the future replacement cycles of the air handlers.

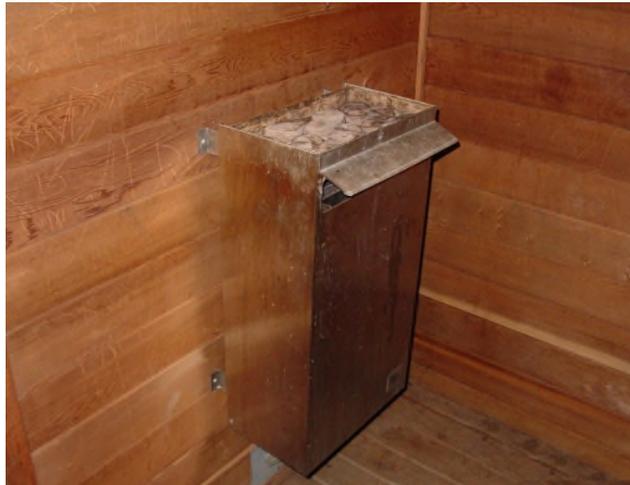
2017 - No change to this component.

2012 - No change to this component. These are the sauna heaters located at the clubhouse.

The original heaters have been replaced. The actual date this component was placed into service is not available. For budgeting purposes, this date has been estimated based on its condition at our most recent field inspection.

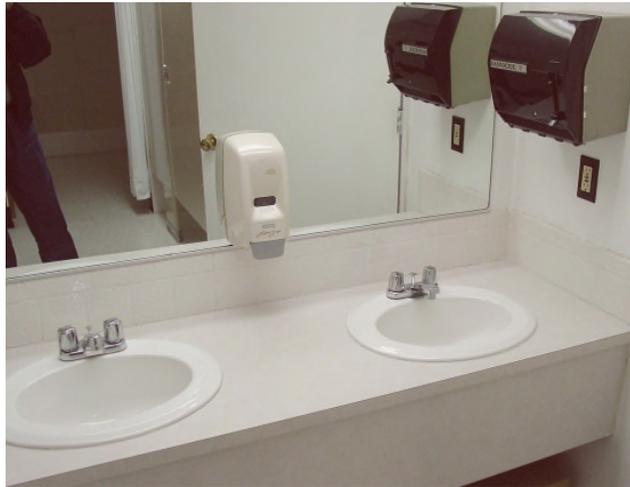
2017 - No change to this component.

2012 - These are the plumbing fixtures located in the restrooms and kitchen in the clubhouse. New faucets were installed in the restroom in 2010 at minimal cost.

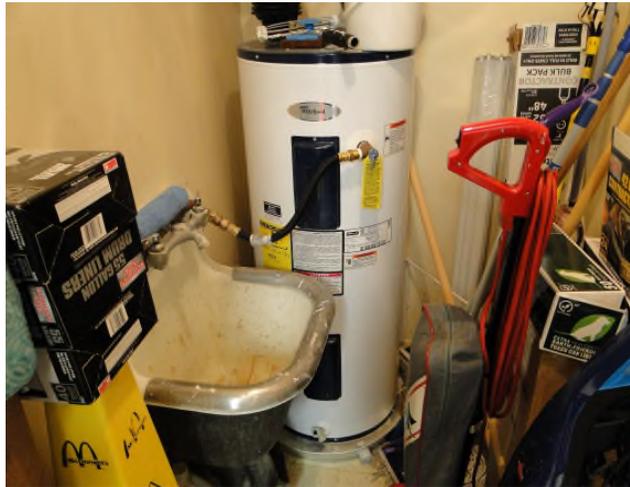
2017 - The water heater was replaced in 2014. The useful life was reduced based upon the life of the last heater.

2012 - This is the 40 gallon electric water heater. Per the client, this was replaced in 2006.

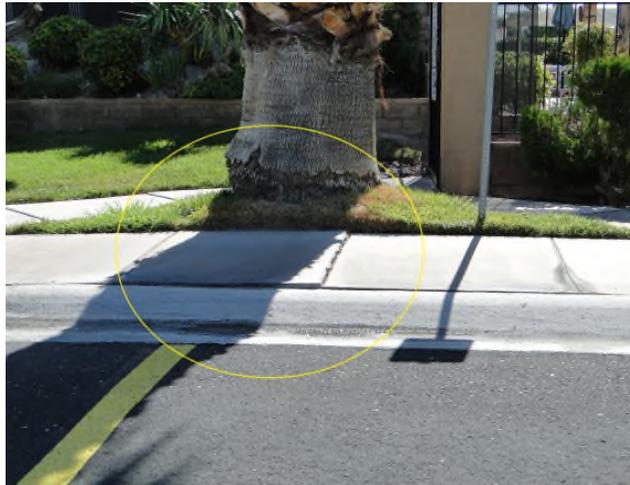
Grounds - Concrete, Repairs (++)

2017 - The association is responsible for concrete curbing, sidewalks and other flatwork in the community. In the past, because of the association's financial state we have minimized this funding to be handled on an as-needed basis through the operating fund. NRS now requires these types of components, which may not in the past have been funded, be funded or commented as to why they are not. +++ The 2017 site visit revealed a number of lifted slabs usually adjacent to or near trees. +++

2012 - We must emphasize that this is a conservative estimate for concrete repairs, considering the age of the community. We recommend that this budget be revisited and increased in the future as reserve funding levels increase. These are the concrete sidewalks, curbs, and drainage swales located throughout the community. It is estimated that a percentage of the concrete installations will require repair or replacement through time. The actual condition of these installations should be monitored and the percentage of replacement and remaining life estimates adjusted accordingly.

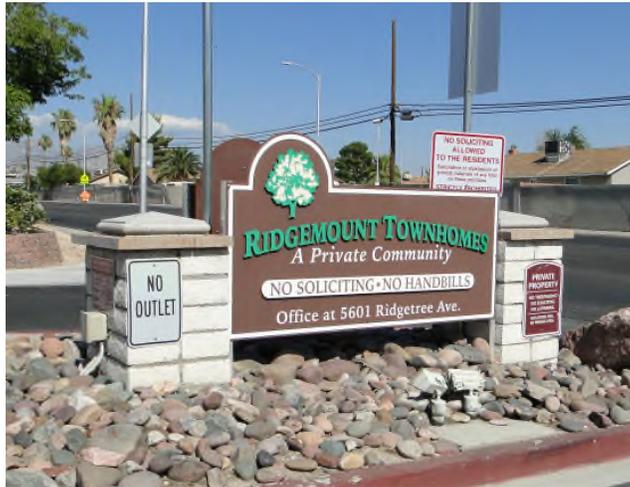
2017 - Adjusted estimated dollars and useful life.

2012 - Includes the wood entry sign and the signage located at the clubhouse.

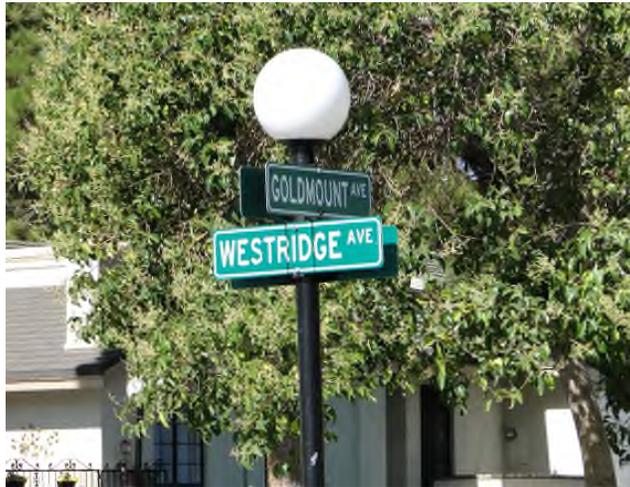
2012 - No change to this component.

2012 - These are the various street signage located throughout the community.

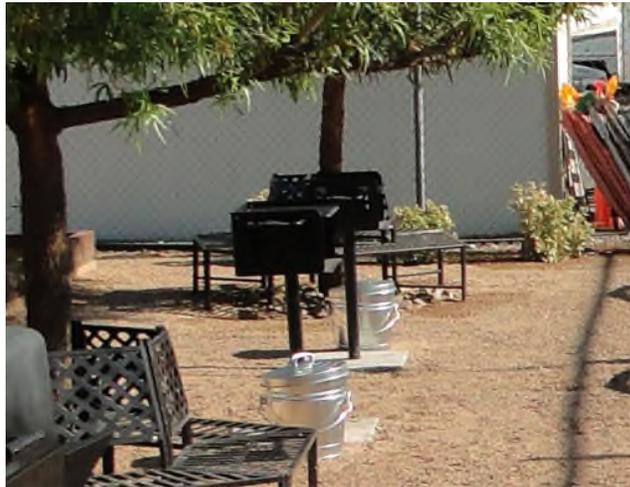
2017 - No change to this component.

2012 - There is a portable gas barbecue and two installed pedestal barbecues in the court park. The gas barbecue appears to have been used and donated. We have not included it in budgeting.

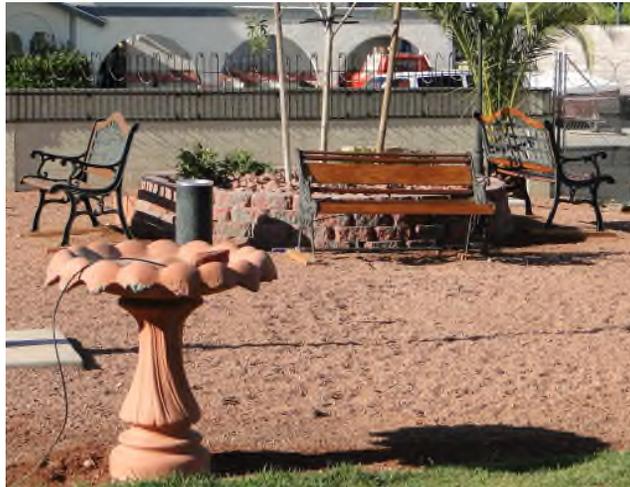
The dog park is located on the south end of the development and is sand and DC covered. It also contains lighting and inexpensive portable seating. Most items can be replaced via operating funds. The ground cover replenishment can be covered in general landscaping or the ground cover component listed in the general park inventory.

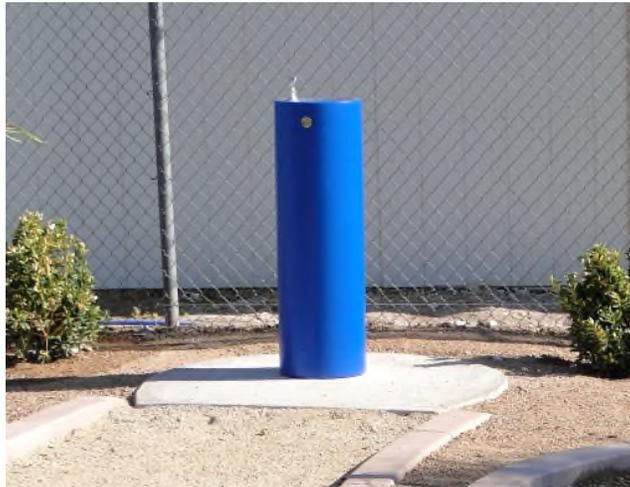
2017 - No change to this component.

2012 - This drinking fountain is located in the court park. It is a powder-coated steel casing.

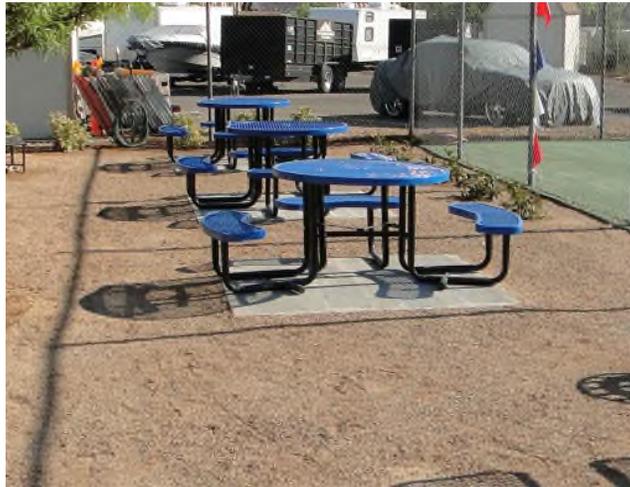
2017 - No change to this component.

2012 - This coated steel furniture is located in the court park. It is vinyl coated steel. The trash cans are powder coated steel.

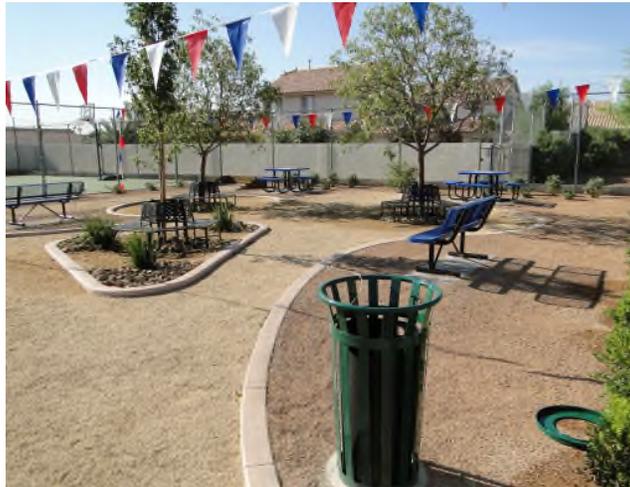
2017 - No change to this component.

2012 - There are two new "park" areas which we will refer to as the "court" and "island" parks. The court park is 7200sf and the island park is 7900sf. The ground covering for décor and paths is crushed stone and DC. It generally will need periodic replenishment. Since all of the material will not required replenishment at any one time, we have assumed a replenishment of 50%. A cubic yard will provide 2" covering of 162sf. There should be sufficient funding to also provide for periodic replenishment of the dog park.

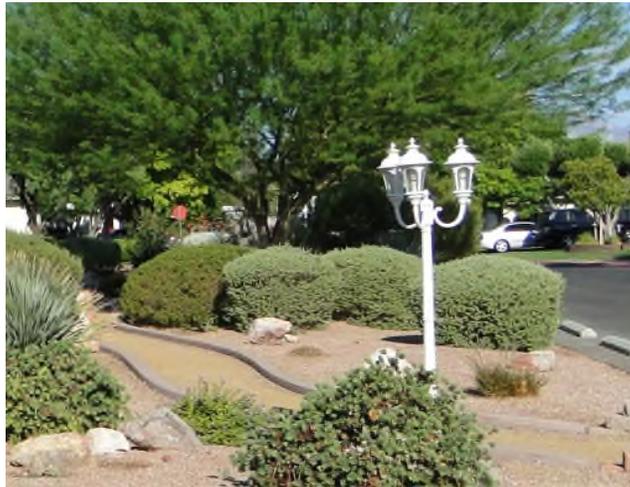
2017 - No change to this component.

2012 - These 4 triple white light poles located in the "island" park and the 4 triple black lantern style light poles in the dog park.

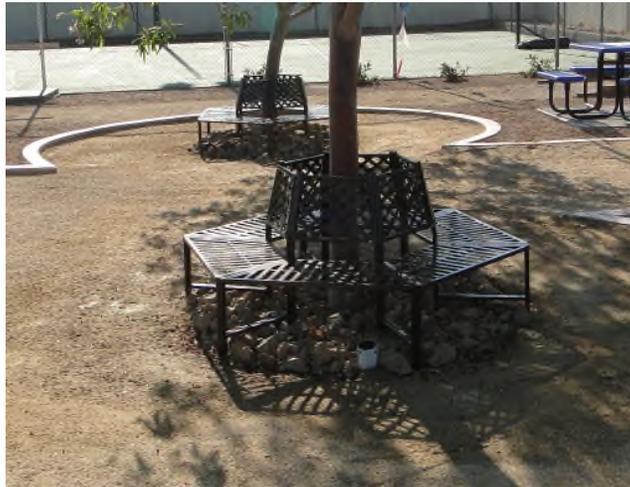
2017 - No change to this component.

2012 - These "wrought iron" style bench seats that surround 5 trees are located in the court park. Internet cost plus tax, shipping and install.

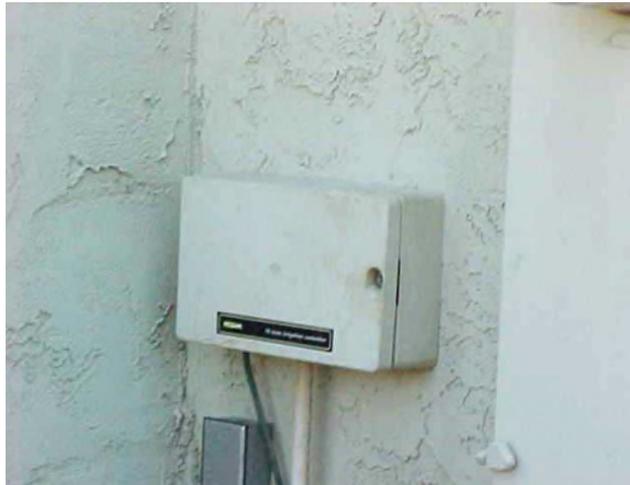
2017 - Controllers are replaced on an as-needed basis.

2012 - These are the irrigation controllers located throughout the community
The inventory was provided by the association and lists 19 controllers. Dates have been revised to account for ongoing replacements.
