Reserve Analysis Report

Ridgemount Association

Las Vegas, Nevada

Version 2017-001 Final

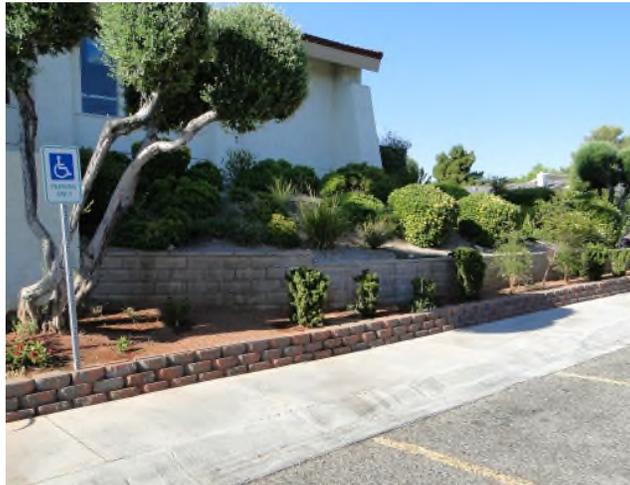
2017 - Placed in service and remaining life estimates adjusted as well as estimated dollars.

2012 - In addition to the expenditures notes below, an additional sum of approx \$47k-\$50k has been spent on renovating the landscaping around buildings as building renovation have been completed over the past years. All of these expenses were not planned for and would not normally be charged to reserves unless through a special reserve assessment.
